INDOOR AIR QUALITY ASSESSMENT

Minnechaug Regional High School
621 Main Street
Wilbraham, Massachusetts

Prepared by:
Massachusetts Department of Public Health
Center for Environmental Health
Emergency Response/Indoor Air Quality Program
February 2007

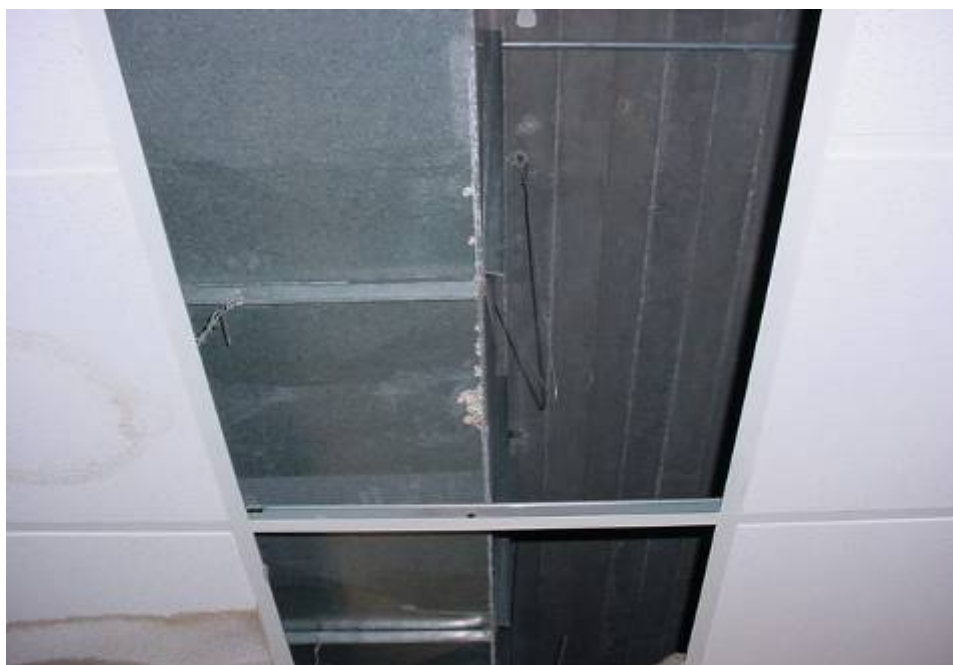
Picture 2

The building has had water infiltration issues through the roof and window systems over the years, as evidenced by water-damaged/missing ceiling tiles (Picture 2) throughout the building and efflorescence on the underside of roof decking (Picture 3). Efflorescence is a characteristic sign of water damage to building materials, but it is not mold growth. As moisture penetrates and works its way through building materials (e.g., plaster), water-soluble compounds dissolve, creating a solution. As this solution moves to the surface, the water evaporates, leaving behind white, powdery mineral deposits. The US Environmental Protection Agency (US EPA) and the American Conference of Governmental Industrial Hygienists (ACGIH) recommend that porous materials be dried with fans and heating within 24 to 48 hours of becoming wet (US EPA, 2001; ACGIH, 1989). If porous materials are not dried within this time frame, mold growth may occur.

Missing/Water Damaged Ceiling Tiles, Library

8. Remove water-damaged ceiling tiles in a manner consistent with recommendations found in “Mold Remediation in Schools and Commercial Buildings” published by the US EPA (US EPA, 2001). This document is available from the US EPA website at: http://www.epa.gov/iaq/molds/mold_remediation.html.

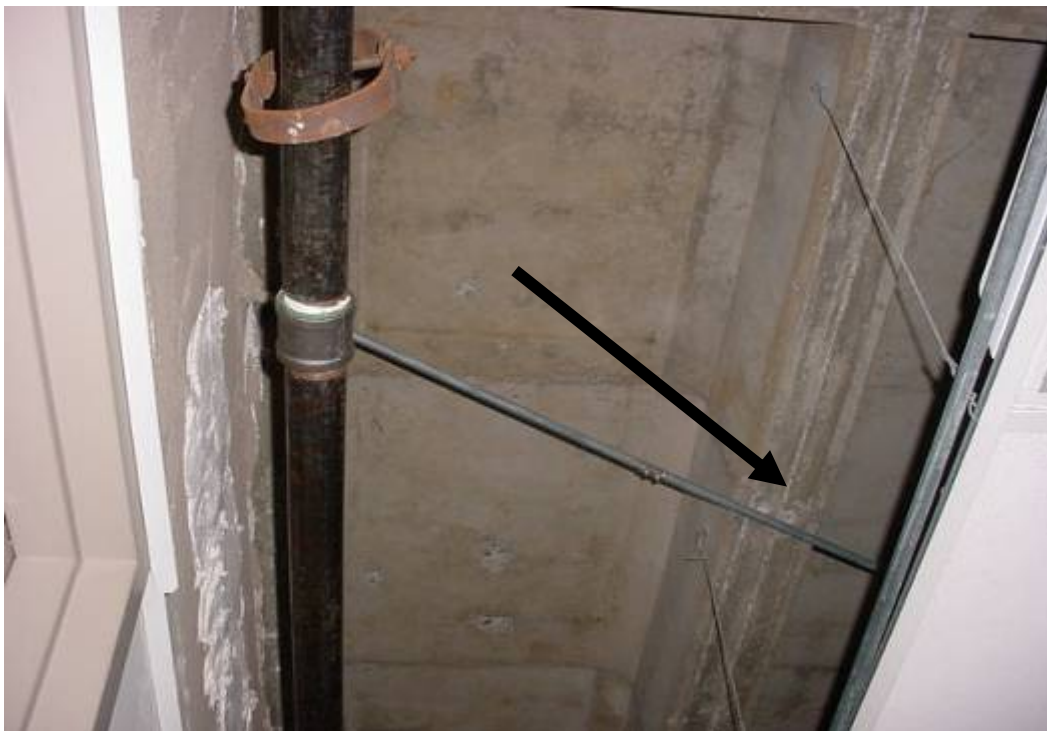
Picture 3

Efflorescence On The Underside Of Roof Decking

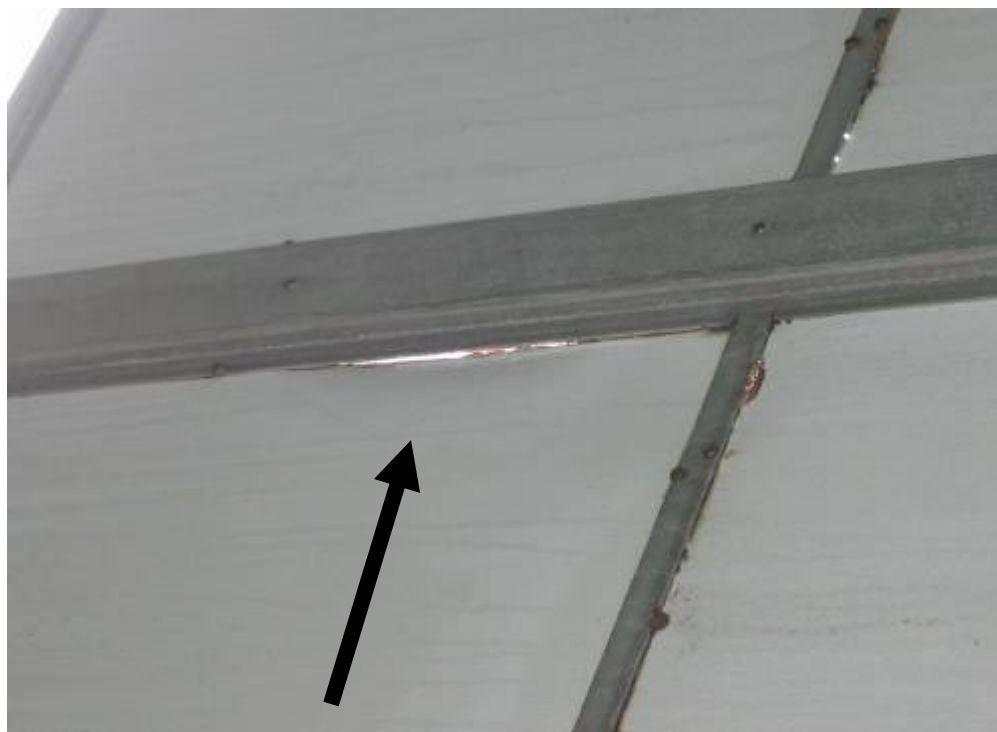
Picture 4

Pool treatment odors were detected in the hallways outside of the indoor pool area Hallways B and E during the January 12, 2007 visit ([Map 1](#)). These odors are likely the result of breaches in the building envelope in the pool area and a lack of adequate exhaust ventilation to remove moisture from the pool area¹. CEH staff identified a number of breaches to exterior wall panels of pool area (Picture 4), as well as spaces around the exterior door of the pool (Picture 5). The presence of condensation on the doorframe (Picture 6) indicates that cold air is cooling the doorframe. Condensation is the collection of moisture on a surface with a temperature below the dew point. The dew point is a temperature determined by air temperature and relative humidity. For example, at a temperature of 73° F and relative humidity of 57 percent indoors, the dew point for water to collect on a surface is approximately 57° F (IICRC, 2000). The outdoor measured temperature was 42° F on January 12, 2007. Therefore, any surface that had a temperature below 57° F (e.g., the doorframe) would be prone to condensation generation under these temperature and relative humidity conditions.

Breaches Around Wall Panels In Pool

7. Seal all breaches to the exterior wall of the pool area with an appropriate material to prevent outdoor air penetration. Consider consulting a building engineer for advice on the best methods for sealing this wall.

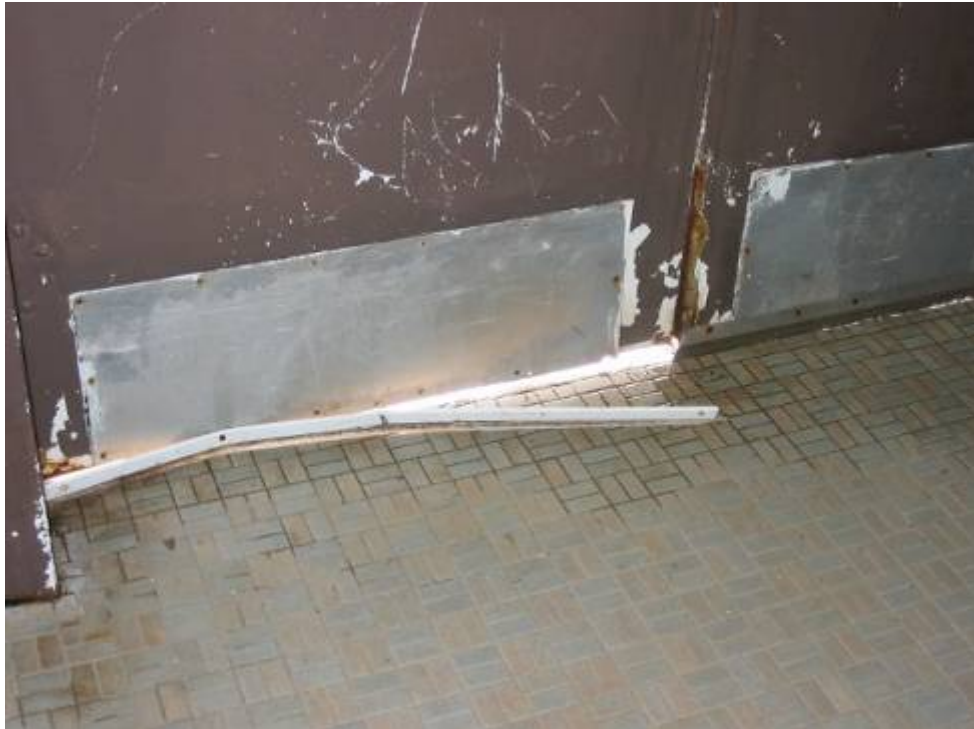
Picture 5

Breaches to Exterior Door in Pool Area

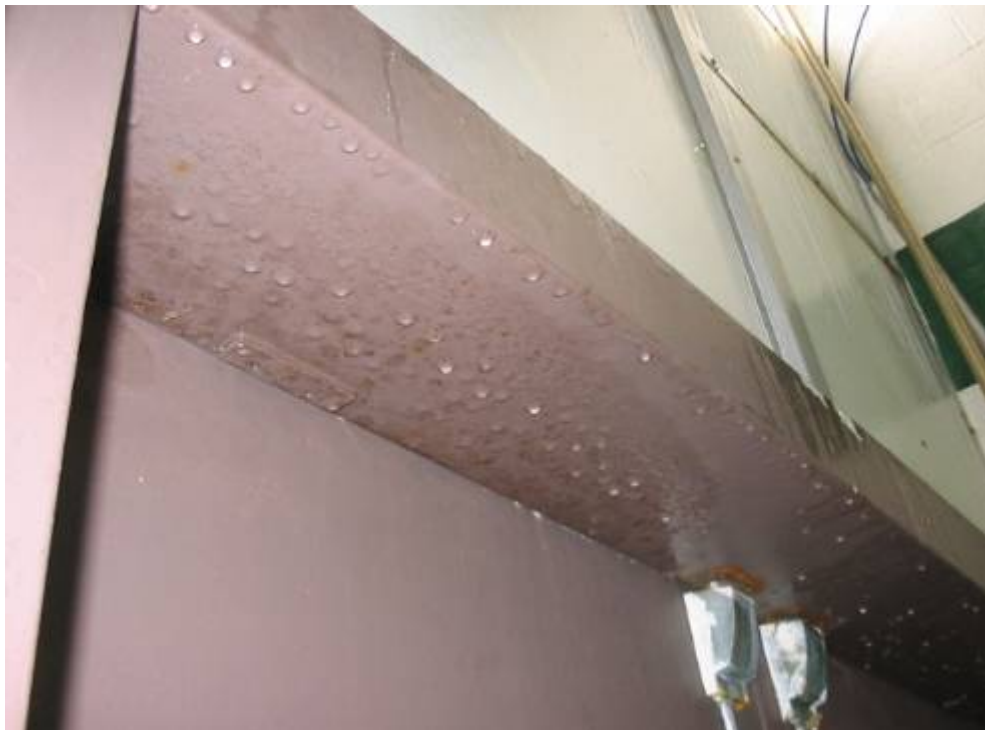
Picture 6

Exterior Door Of Pool, Note Condensation On Doorframe

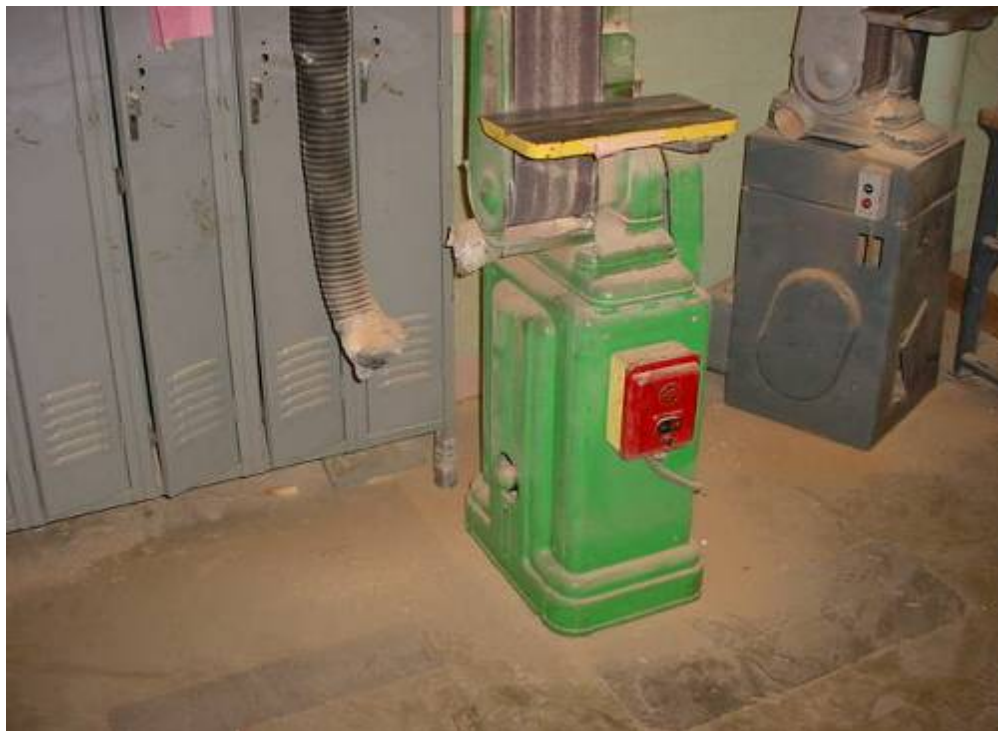
Picture 7

A number of other conditions that can affect indoor air quality were noted during the assessment. A noticeable wood dust odor was detected in the hallway outside of the wood shop. A space was noted beneath the wood shop door, which can allow dusts/odors to migrate into adjacent areas of the school. A number of wood cutting/sanding machines are connected to the ducted wood-dust collection system, other equipment is not. The flexible plastic duct connecting one machine to the wood-dust collection system (Picture 7) was breached, providing a means of egress for wood dust into the classroom environment. Wood dust is a fine particulate, which can be easily aerosolized and become irritating to the eyes, nose, throat and respiratory system. In addition, under certain conditions, wood dust is a fire hazard.

Disconnected Wood Dust Collector Hose

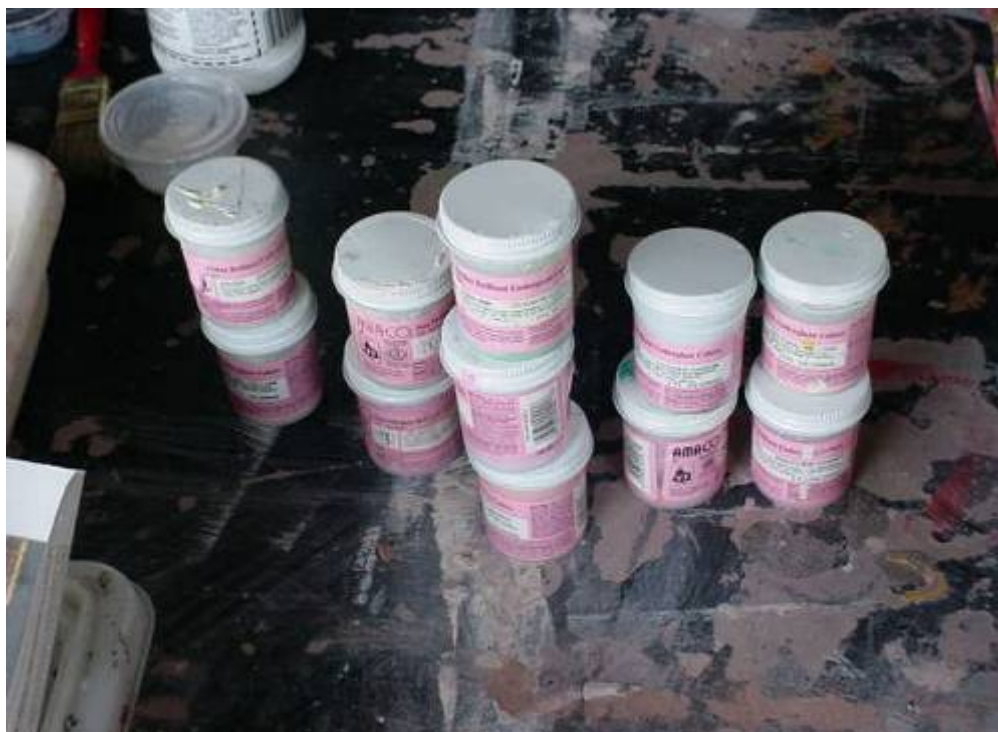
Picture 8

Of note was the presence of lead-containing pottery glazes in the art room (Picture 8). During the pottery firing process, lead fumes may emanate from kilns. Lead exposure to women of reproductive age poses a number of risks to developing fetuses (ATSDR, 1999). Lead exposure, particularly in the early stages of pregnancy when a woman may not know that she is pregnant, may result in adverse effects from *in utero* exposure to lead. Lead exposure in males has been associated with reduced fertility because of effects on sperm (ATSDR, 1999). It is highly recommended that the use of non-lead containing materials be substituted for lead-containing glazes/materials.

Pottery Glazes Containing Lead

9. Discontinue use of lead-containing pottery glazes. Replace glazes with non-lead products. School department officials should contact the MDPH Childhood Lead Poisoning Prevention Program for information concerning remediation of lead contaminated surfaces in the pottery shop.

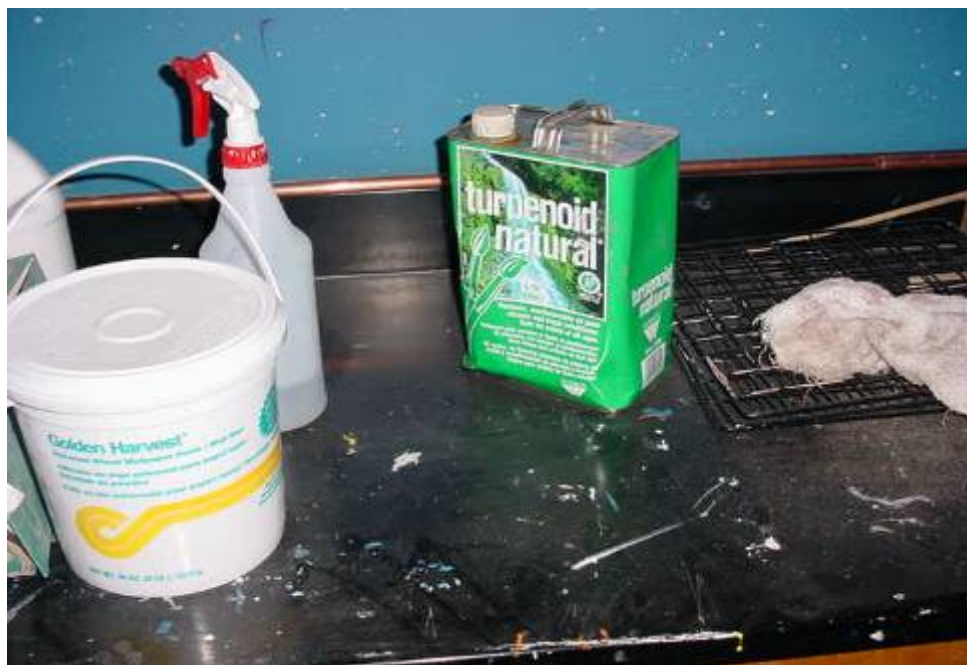
Picture 9

A number of turpentine containers were observed in the art room (Picture 9). These products contain volatile organic compounds (VOCs), which readily evaporate and can be irritating to eyes, nose and throat. These products are flammable as well, and should be kept away from heat sources. It is recommended that flammables be stored in a cabinet which meets the criteria set forth by the National Fire Protection Association (NFPA) (NFPA, 1996). This type of material should be used in a well ventilated area. Lack of ventilation can lead to the migration of VOCs from this area to hallways and other classrooms.

Turpentine Container in Art Room

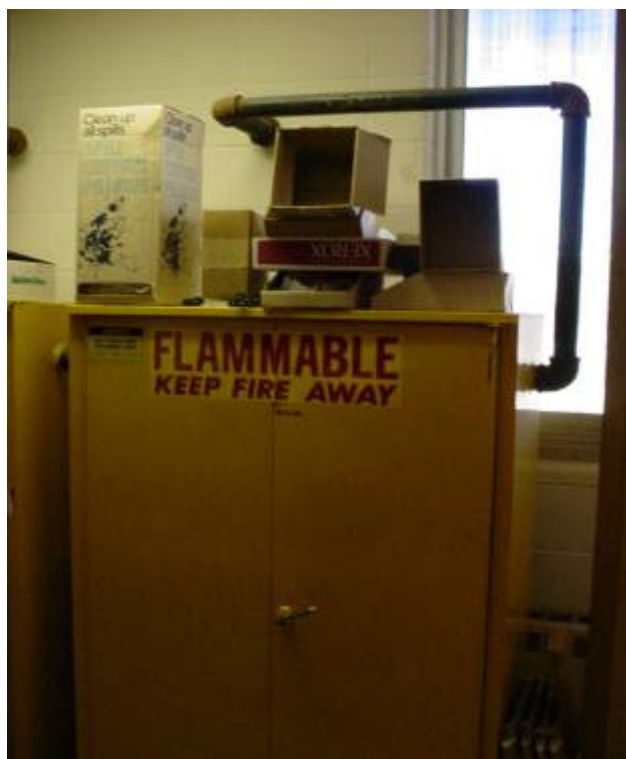
Picture 10

- Venting of the flammable chemical storage cabinet: Flammable materials in the chemical storeroom are stored in flameproof cabinets (Picture 10). An exhaust vent was installed to each flameproof cabinet. The National Fire Prevention Association

(NFPA) does not require venting in flammable storage cabinets; however, if cabinets are vented, it must be vented directly outdoors and in a manner that does not compromise the specific performance of the cabinet (NFPA, 1996). No air backflow device could be identified in this vent pipe. Proper design of exhaust vents should prevent air back flow into the cabinet. Limiting oxygen supply within a flameproof cabinet is important in preventing spread of chemical-related fires. In their current condition, the pipes can provide an oxygen supply to the interior of the flameproof cabinet. If outdoor air back flows into the cabinet through the vent pipe, off-gassing chemicals can also be forced from the flammable storage cabinet into the storeroom.

Vented Flameproof Cabinet in Chemical Storeroom

19. Disconnect the flammable storage cabinet from the vent pipes and reseal the cabinet with its original bung hole caps.
20. Install guard rails along chemical storage area shelves.
